**Flood Control Project Maintenance
Levee Inspections**
LMA District Cover Sheet
Spring 2020 Levee Inspection Results

Reclamation District No. 2085 Kasson

Spring 2020 Levee Inspection Results

Waterway			Bank	Unit Miles
Unit No. 01 San Joaquin River			Left	5.29
	Spring (March - May)	Summer (June - August)	(September - November) Fall	Winter (December - February)
Unit Maintenance Rating (Fall Only)				
Date of Inspection	4/1/2020 - 4/1/2020			
DWR Inspector	Alberto De Leon			
Accompanied By	Ralph Timan RD2085			
	Daniel de Graaf, PE Provost and Pritchard Consulting

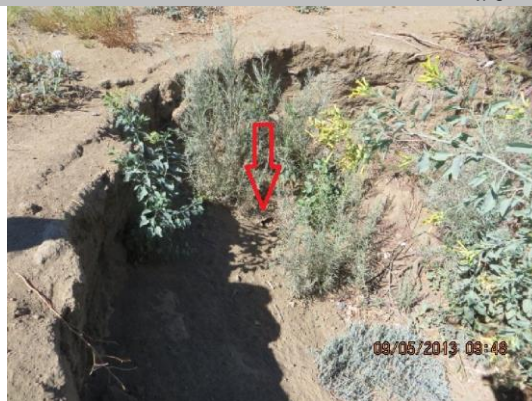
Photo 1 of 3 : UCIP_SP_2020_52493_62262.jpg

Comment Code						
Inspector Comment						
DS_ID:20677 FS_ID:52493 EP_NO: N/A Repair Type: No Action Needed Crossing Status: Found UCIP Comments: Pipe has been removed by LMA.Previous:Pipe abandoned. Erosion around pipe on WS slope. Pipe severely corroded. Pier badly damaged. FIELD_STRUCT_DESC: *REMOVED* 14-inch steel drainage pipe through the levee, 4.5 feet below the crown. Pump on pile structure in ditch on the landside (LS). Siphon breaker in corrugated metal pipe (CMP) riser on the waterside (WS) shoulder. Pipe removed by LMA. (Permit Application No. T2013179, 2014 - Surinder Sandhu, submitted to CVFPB. Permit was not needed per CVFPB review). [Additional Reference(s): DWR Levee Log, 2005. USACE San Joaquin O&M Manual 11, 1968, (HLM 0.47)]. FS Date: 9/5/2013

(Pipe removed by LMA)Pipe on WS with erosion into levee slope.

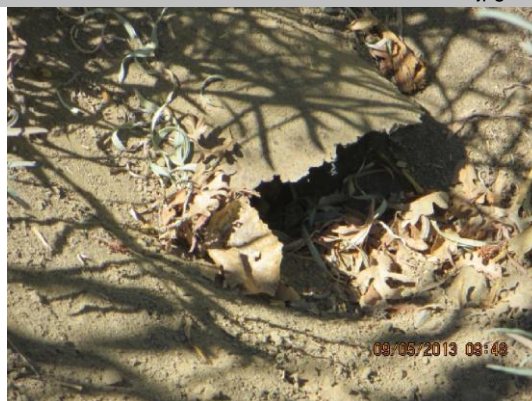
Photo 2 of 3 : UCIP_SP_2020_52493_62261.jpg

Pipe removed from WS toe.

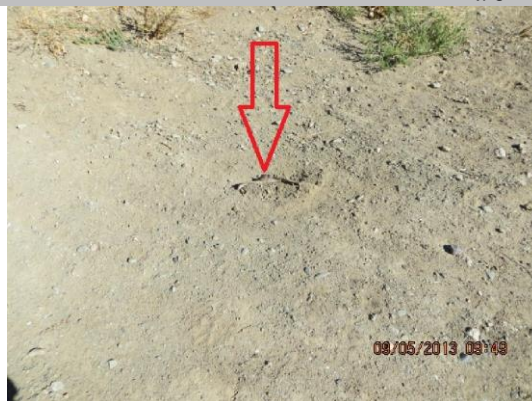
Photo 3 of 3 : UCIP_SP_2020_52493_62260.jpg

Siphon breaker in 24-inch CMP riser on WS shoulder was removed by LMA.

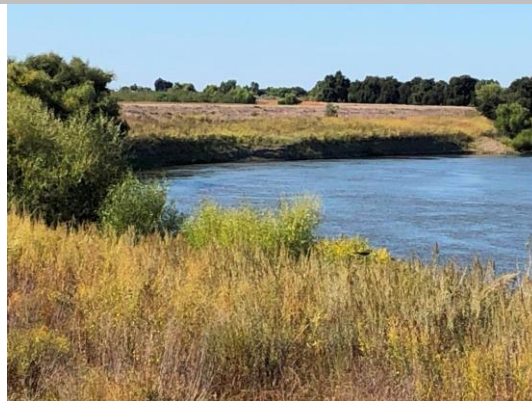
Photo 1 of 3 : SP_2020_RD2085_113_1_20200228_00001.jpg

LM Start	1.15	Rating **	M	Issue No.	1
LM End	1.26	Issue Type +	Ma	Location *	WS
Category	Supplemental			GPS Latitude/Longitude	
				Start	End
Item	DWR Erosion Survey			37.715996 °	37.715996 °
				-121.291229 °	-121.291229 °
DWR ID	RD2085U01RM62.43				
Comment Code					
Inspector Comment					
Site ID: RD2085U01RM62.43 09/17/2019: No significant change has been observed at the site. The site is covered with dense and tall vegetation. 11/02/2017: The erosion was reported to DWR by LMA. The site is located at the outside of a slight river bend. Both levee slope and river bank are covered with dense vegetation.

Looking downstream at the erosion site.

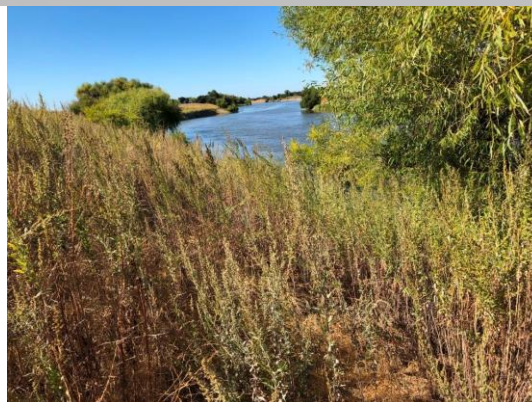
Photo 2 of 3 : SP_2020_RD2085_113_1_20200228_00002.jpg

Looking downstream at the erosion site. Note the dense vegetation and the trees at the upstream of the erosion.

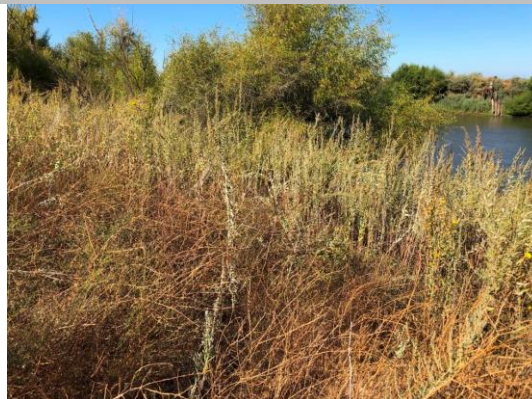
Photo 3 of 3 : SP_2020_RD2085_113_1_20200228_00003.jpg

Close-up view of the erosion.

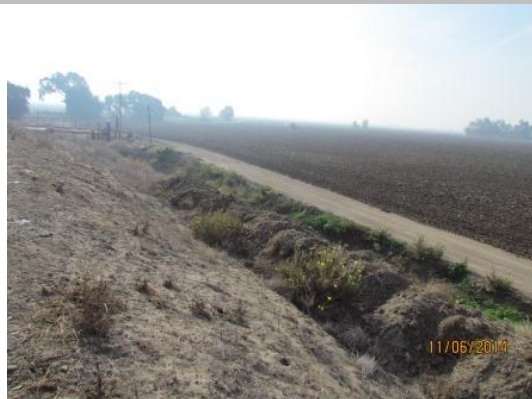
Photo 1 of 1 : SP_2020_RD2085_113_6_20200228_00004.jpg

LM Start	1.34	Rating **	M	Issue No.	6
LM End	1.38	Issue Type +	En	Location *	LS
Category	Earthen Levee			GPS Latitude/Longitude	
				Start	End
Item	Encroachments			37.714265 °	37.714056 °
				-121.289641 °	-121.289069 °
DWR ID	DWR_RD2085_01_s_2012_6				
Comment Code					
DT : Ditch					
Inspector Comment					
A drainage ditch is located at the levee toe.

View of the ditch at the landside levee toe.

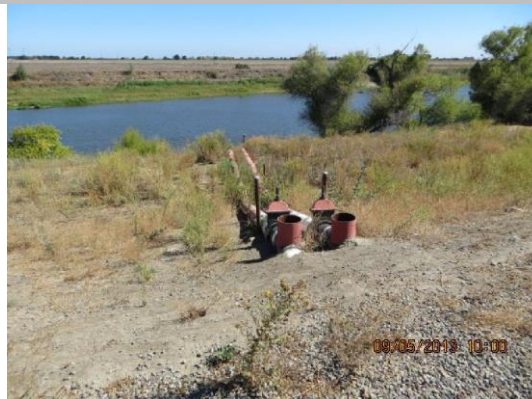
Photo 1 of 3 : UCIP_SP_2020_22285_38010.jpg

LM Start	1.35	Rating **	M	Issue No.	61	
LM End	1.35	Issue Type +	En	Location *		
Category	Supplemental			GPS Latitude/Longitude		
				Start	End	
Item	DWR UCIP Field Study			37.714404 °	37.714404 °	
				-121.289469 °	-121.289469 °	
DWR ID	24055					
Comment Code						
Inspector Comment						
DS_ID:24055						
FS_ID:22285						
EP_NO: N/A						
Repair Type: Non-Urgent						
Crossing Status: Found						
UCIP Comments: No permit identified for this modified crossing.						
FIELD_STRUCT_DESC: 12-inch steel drainage pipe through the levee, 3 feet below the crown. Pump mounted on pile structure in ditch on the landside (LS). Gate valve and siphon breaker in a 12-inch steel riser on the waterside (WS) shoulder. (Permit No. 8189, 1972 - Reclamation District No. 2085).						
FS Date: 9/10/2013

Pipe, gate valve, and siphon breaker visible on WS slope.

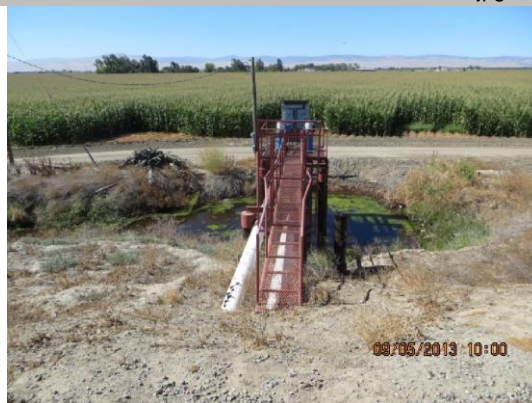
Photo 2 of 3 : UCIP_SP_2020_22285_38009.jpg

Pipe, pump, and walkway visible on LS toe.

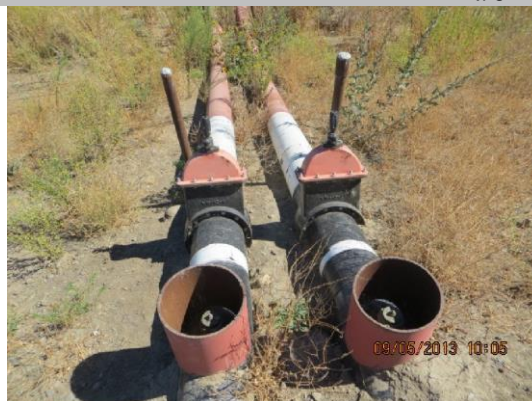
Photo 3 of 3 : UCIP_SP_2020_22285_38008.jpg

Pipe, gate valve, and siphon breaker visible on WS slope.

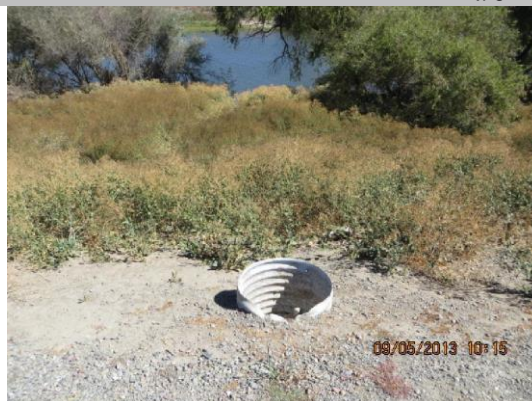
Photo 1 of 3 : UCIP_SP_2020_41351_62268.jpg

Comment Code						
Inspector Comment						
DS_ID:20679 FS_ID:41351 EP_NO: 3975 Repair Type: Non-Urgent Crossing Status: Found UCIP Comments: Pipe abandoned and should be done so properly. Large hole in ground over pipe on WS berm. Pipe rusted through on WS at river bank. No connection to pump on LS toe. FIELD_STRUCT_DESC: *ABANDONED* 10-inch steel drainage pipe through the levee, 4 feet below the crown. Steel plate over pipe end at pump station on the landside (LS) toe. Siphon breaker in a 24-inch corrugated metal pipe (CMP) riser on the waterside (WS) shoulder. (Permit No. 3975, 1962 - Glenn West Trust). [Additional Reference(s): DWR Levee Log, 2005. USACE San Joaquin O&M Manual 11, 1968, (HLM 1.35)]. FS Date: 9/5/2013

Siphon breaker in 24-inch CMP riser on WS shoulder.

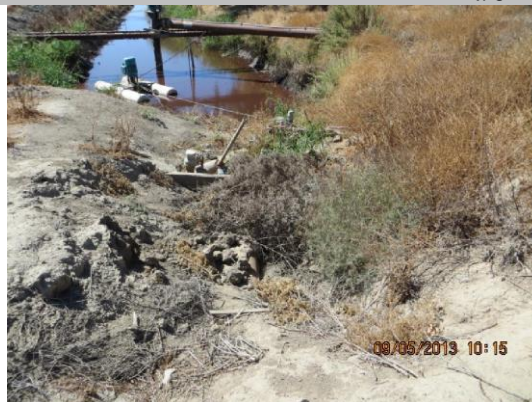
Photo 2 of 3 : UCIP_SP_2020_41351_62267.jpg

Pipe visible at bottom of ditch on LS toe.

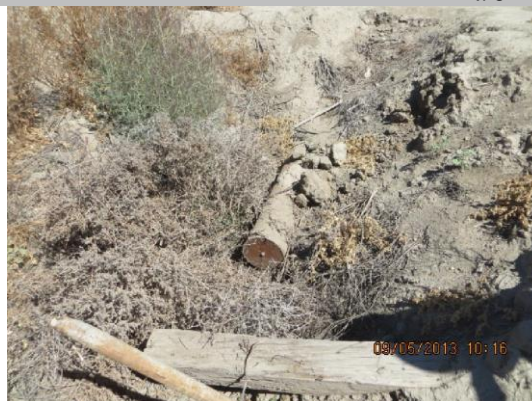
Photo 3 of 3 : UCIP_SP_2020_41351_62266.jpg

Pipe visible at bottom of ditch on LS toe.

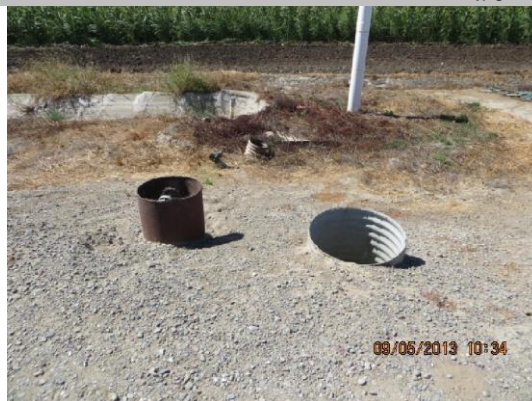
Photo 1 of 3 : UCIP_SP_2020_19423_32962.jpg

DS_ID:20681
 FS_ID:19423
 EP_NO: N/A
 Repair Type: Non-Urgent
 Crossing Status: Found
 UCIP Comments: This pipe is abandoned and should be done so properly.
 FIELD_STRUCT_DESC: 1 of 2: 10-inch pipe through the levee 2.0-feet below the crown. Pump mounted on pile structure in the river. Siphon breaker in 24-inch CMP riser on the LS slope. Power pole on LS toe. Wooden stairs and walkway from the berm to the pump structure. Originally included in the 1968 O&M manual.
 FS Date: 9/5/2013 8:22:24 AM

Siphon breaker in 24-inch CMP riser on LS slope. Possible gate valve at end of concrete channel on LS toe.

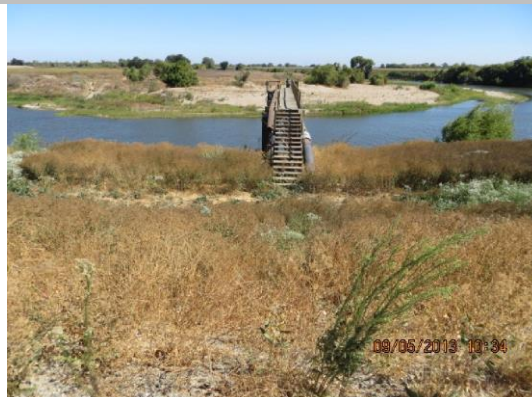
Photo 2 of 3 : UCIP_SP_2020_19423_32961.jpg

Pipe cut at wooden pier. No pump on end of pier for this pipe.

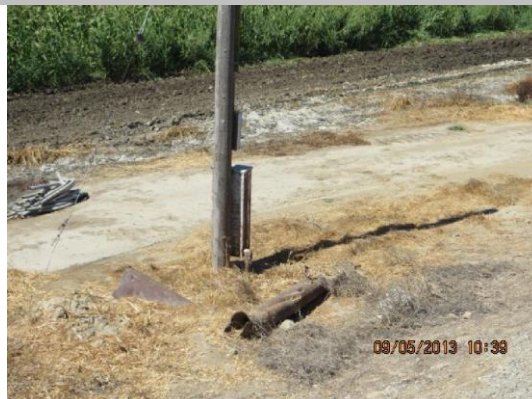
Photo 3 of 3 : UCIP_SP_2020_19423_32960.jpg

Power pole on LS toe.

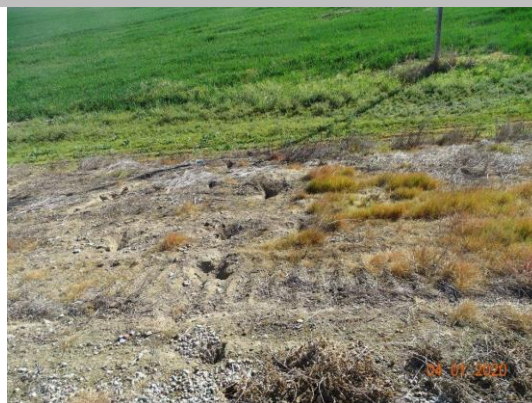
Photo 1 of 1 : SP_2020_RD2085_113_19_20200402_00050.jpg

View of multiple animal burrows on landside slope. Spring 2020

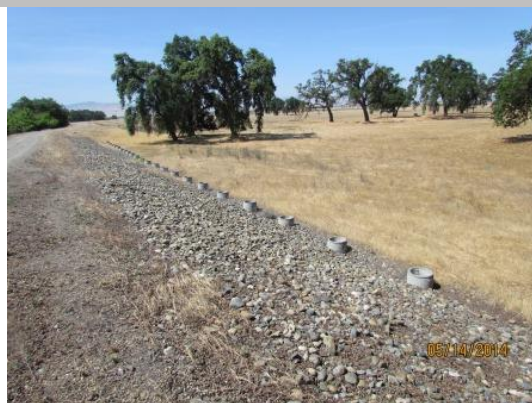
Photo 1 of 1 : SP_2020_RD2085_113_20_20200228_00005.jpg

View of the underseepage relief wells at the landside levee toe.

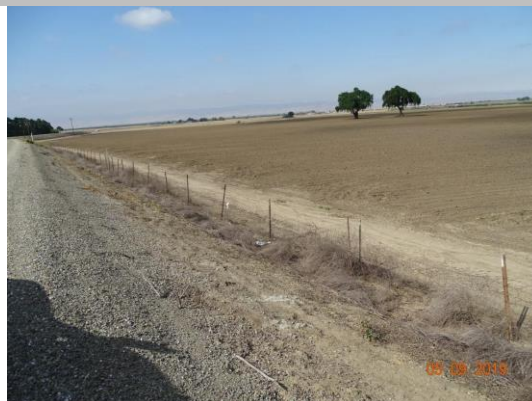
Photo 1 of 1 : SP_2020_RD2085_113_42_20200228_00011.jpg

View of barbed wire fence on landside toe. (Spring 2019)

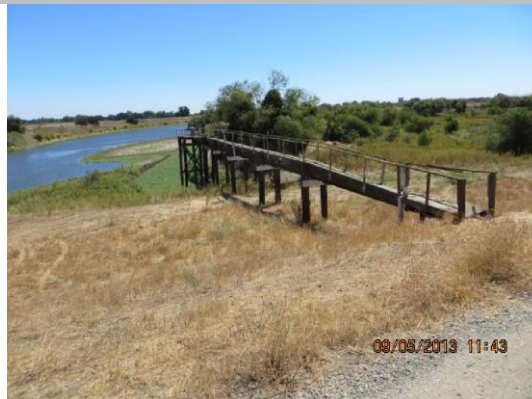
Photo 1 of 3 : UCIP_SP_2020_19431_32983.jpg

LM Start	2.82	Rating **	M	Issue No.	64
LM End	2.82	Issue Type +	En	Location *	
Category	Supplemental			GPS Latitude/Longitude	
				Start	End
Item	DWR UCIP Field Study			37.699698 °	37.699698 °
				-121.276325 °	-121.276325 °
DWR ID	20688				
Comment Code					
Inspector Comment					
DS_ID:20688 FS_ID:19431 EP_NO: 16970 Repair Type: Non-Urgent Crossing Status: Found UCIP Comments: The wooden walkway on the WS slope is in disrepair. FIELD_STRUCT_DESC: 1 of 2: 14-inch steel irrigation pipe through the levee, 2 feet below the crown. Pump on wooden pier on the waterside (WS) slope. Siphon breaker visible next to steel bollard on the landside (LS) slope. Power pole on the LS toe. [Additional Reference(s): USACE San Joaquin O&M Manual 11, 1968, (HLM 2.74)]. FS Date: 9/5/2013

Pump on Wooden pier at WS slope.

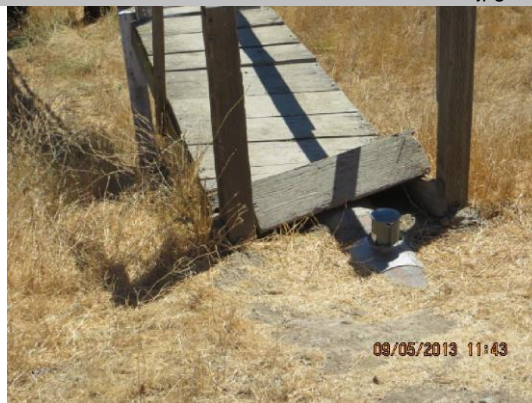
Photo 2 of 3 : UCIP_SP_2020_19431_32982.jpg

Pipe visible under walkway on WS slope.

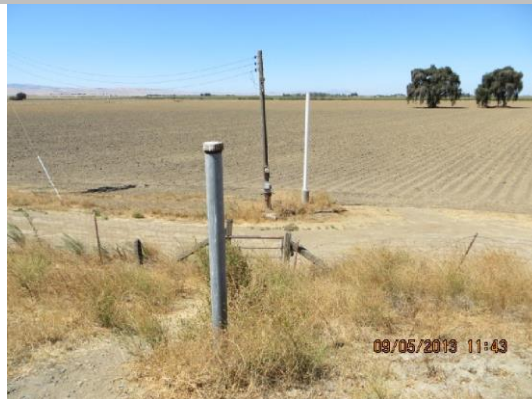
Photo 3 of 3 : UCIP_SP_2020_19431_32981.jpg

Power pole on LS toe with possible PVC riser.

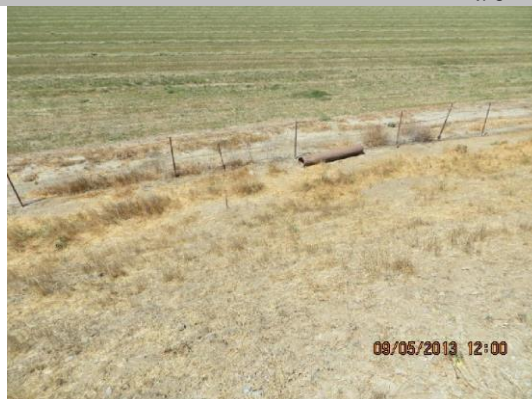
Photo 1 of 3 : UCIP_SP_2020_19433_32990.jpg

LM Start	3.30	Rating **	M	Issue No.	65	
LM End	3.30	Issue Type +	Ma	Location *		
Category	Supplemental			GPS Latitude/Longitude		
				Start		End
Item	DWR UCIP LMA Responsibility			37.693618 °	37.693618 °	
				-121.277639 °	-121.277639 °	
DWR ID	20693					
Comment Code						
Inspector Comment						
DS_ID:20693 FS_ID:19433 EP_NO: N/A Repair Type: Non-Urgent Crossing Status: Found UCIP Comments: Pipe appears abandoned and should be done so properly. FIELD_STRUCT_DESC: *ABANDONED* 10-inch steel storm drainage pipe through the levee, 4 feet below the crown. T-post marks location of pipe at the landside (LS) toe. Steel plate welded over pipe on the waterside (WS) slope. [Additional Reference(s): USACE San Joaquin O&M Manual 11, 1968, (HLM 3.34), As-Built Drawings available, DWG 7-4-1685]. FS Date: 9/5/2013

T-post marking pipe end on LS toe. 10-inch pipe debris on LS toe.

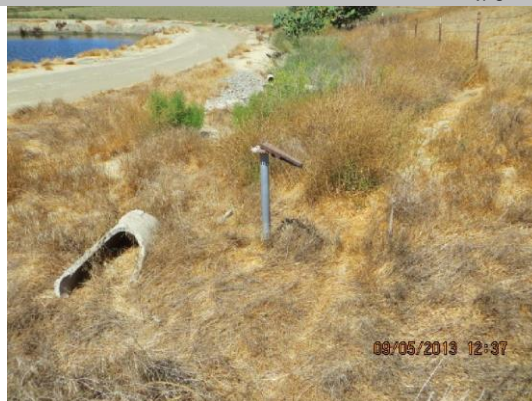
Photo 1 of 3 : UCIP_SP_2020_19435_32993.jpg

LM Start	3.42	Rating **	M	Issue No.	66
LM End	3.42	Issue Type +	En	Location *	
Category	Supplemental			GPS Latitude/Longitude	
				Start	End
Item	DWR UCIP Field Study			37.691966 °	37.691966 °
				-121.278122 °	-121.278122 °
DWR ID	20687				
Comment Code					
Inspector Comment					
DS_ID:20687 FS_ID:19435 EP_NO: 16970 Repair Type: Non-Urgent Crossing Status: Found UCIP Comments: Appears abandoned and if so should be done so properly. FIELD_STRUCT_DESC: *ABANDONED* 2 of 2: 10-inch steel drainage pipe through the levee, 2 feet below the crown. Appears to connect to pump 150 feet off the landside (LS) toe. Possible butterfly valve at the LS toe. Vent on the waterside (WS) shoulder. Steel plate welded over pipe end on the WS toe. FS Date: 9/5/2013

Possible Butterfly valve at LS toe.

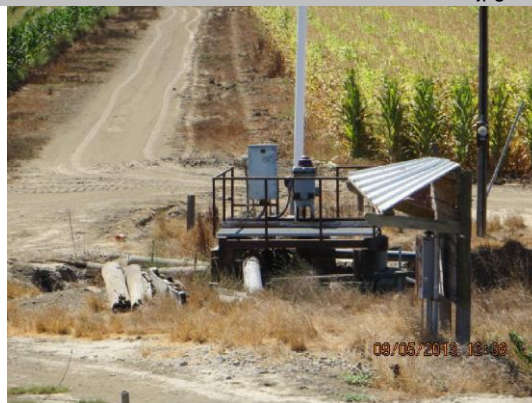
Photo 2 of 3 : UCIP_SP_2020_19435_32992.jpg

Possible connection at pump 150-feet off LS toe.

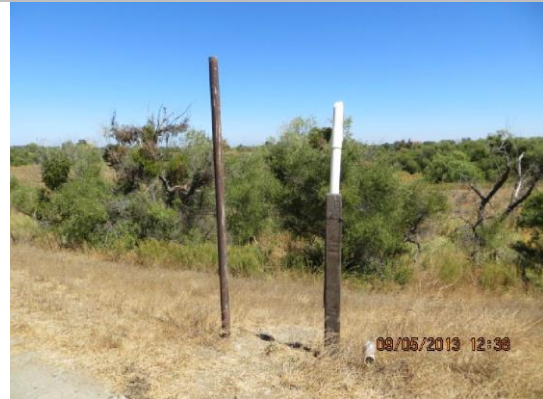
Photo 3 of 3 : UCIP_SP_2020_19435_32991.jpg

Vent on WS shoulder.

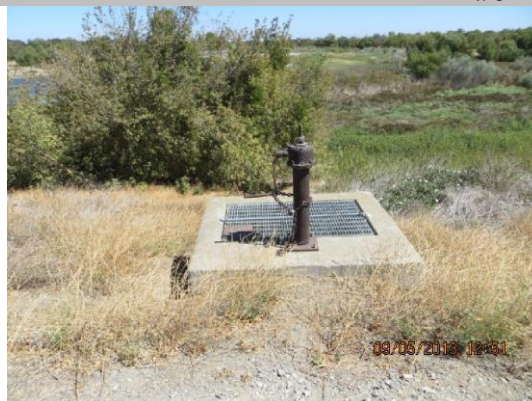
Photo 1 of 3 : UCIP_SP_2020_19436_32997.jpg

LM Start	3.80	Rating **	A/W	Issue No.	67
LM End	3.80	Issue Type +	Ma	Location *	
Category	Supplemental			GPS Latitude/Longitude	
				Start	End
Item	DWR UCIP LMA Responsibility			37.686976 °	37.686976 °
				-121.276838 °	-121.276838 °
DWR ID	20683				
Comment Code					
Inspector Comment					
DS_ID:20683 FS_ID:19436 EP_NO: N/A Repair Type: No Action Needed Crossing Status: Found UCIP Comments: FIELD_STRUCT_DESC: 30-inch by 30-inch reinforced concrete box drainage culvert through the levee, 12 feet below the crown. Slide gate in concrete riser on the waterside (WS) slope. Concrete U-shaped headwalls on both ends. Flap gate on the WS end. Two concrete cutoff walls. [Additional Reference(s): DWR Levee Log, 2005. USACE San Joaquin O&M Manual 11, 1968, (HLM 3.71)]. FS Date: 9/5/2013 9:49:55 AM

Slide gate in Concrete riser on WS shoulder.

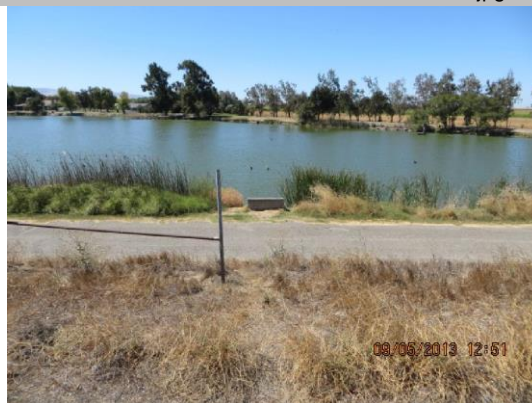
Photo 2 of 3 : UCIP_SP_2020_19436_32996.jpg

Concrete headwall off LS toe.

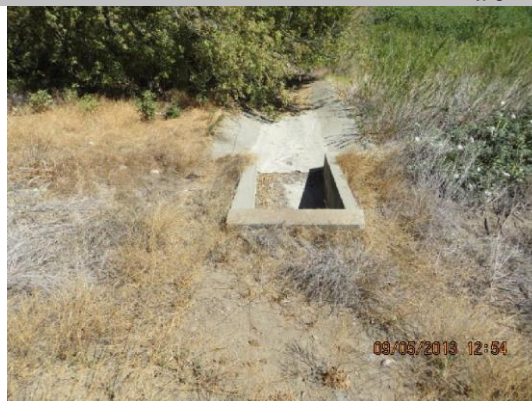
Photo 3 of 3 : UCIP_SP_2020_19436_32995.jpg

Concrete U-shaped headwall on WS slope.

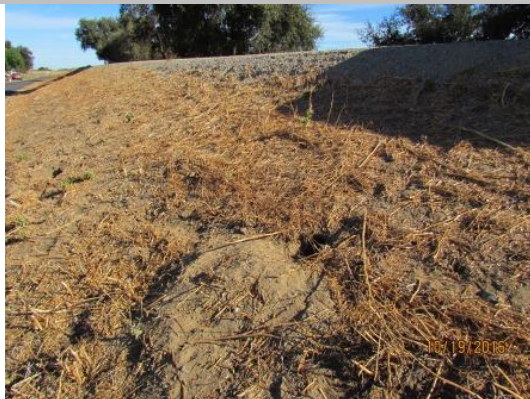
Photo 1 of 1 : SP_2020_RD2085_113_36_20200228_00010.jpg

LM Start	3.81	Rating **	M	Issue No.	38
LM End	3.81	Issue Type +	Ma	Location *	WS
Category	Earthen Levee			GPS Latitude/Longitude	
				Start	End
Item	Animal Control			37.686774 °	37.686774 °
				-121.276810 °	-121.276810 °
DWR ID	DWR_RD2085_01_f_2018_38				
Comment Code					
A3 : No rodents visible, but rodent burrows visible; need to backfill and compact or grout burrows.					
Inspector Comment					
There is a large rodent hole on the waterside slope.

View of the rodent holes on the levee slope.

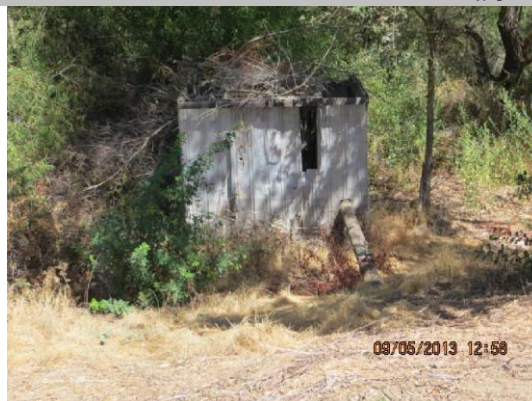
Photo 1 of 3 : UCIP_SP_2020_19443_33002.jpg

LM Start	4.03	Rating **	M	Issue No.	68
LM End	4.03	Issue Type +	En	Location *	
Category	Supplemental			GPS Latitude/Longitude	
				Start	End
Item	DWR UCIP Field Study			37.683642 °	37.683642 °
				-121.275792 °	-121.275792 °
DWR ID	20684				
Comment Code					
Inspector Comment					
DS_ID:20684 FS_ID:19443 EP_NO: N/A Repair Type: Non-Urgent Crossing Status: Found UCIP Comments: This pipe appears abandoned and should be done so properly. FIELD_STRUCT_DESC: 6-inch steel irrigation pipe through the levee, 4 feet below the crown. Pump house on the waterside (WS) berm. Siphon breaker in a 24-inch corrugated metal pipe (CMP) riser on the landside (LS) shoulder. Vent on the WS toe. 2-inch galvanized iron electrical conduit at the same location. [Additional Reference(s): DWR Levee Log, 2005. USACE San Joaquin O&M Manual 11, 1968, (HLM 3.95)]. FS Date: 9/5/2013

Pumphouse and pipe visible on WS toe.

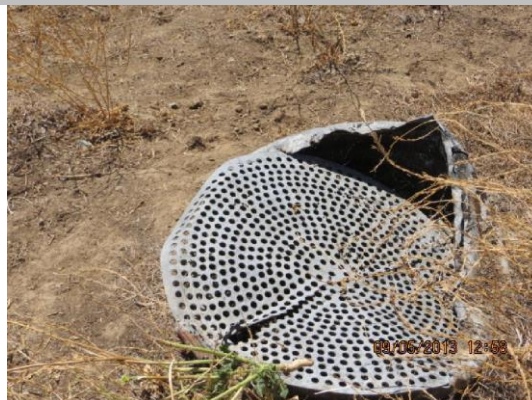
Photo 2 of 3 : UCIP_SP_2020_19443_33001.jpg

Siphon breaker on vent in 24-inch CMP riser on LS shoulder.

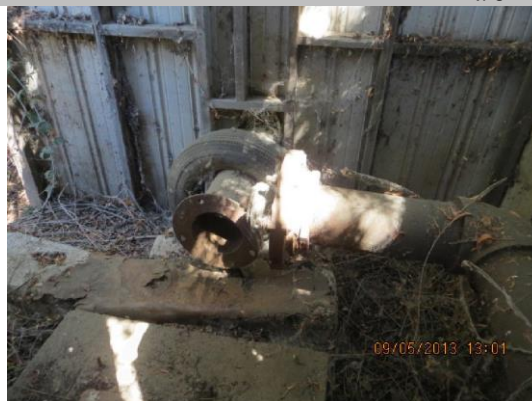
Photo 3 of 3 : UCIP_SP_2020_19443_33000.jpg

Pump missing from pipe in pumphouse on WS toe.

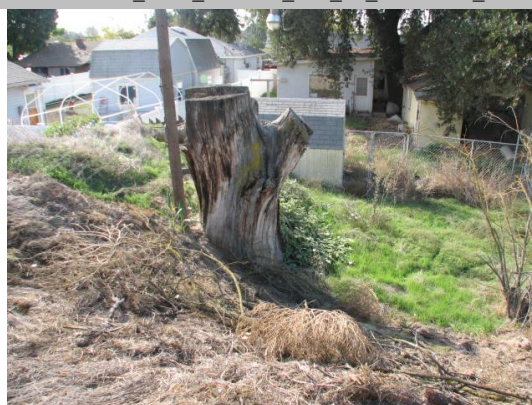
Photo 1 of 1 : SP_2020_RD2085_113_32_20200228_00007.jpg

11/03/2011 Large stump on landside slope.

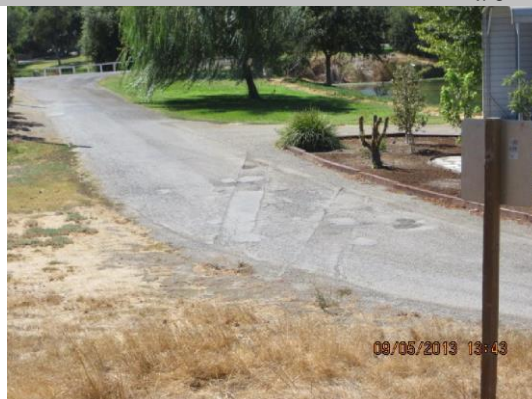
Photo 1 of 3 : UCIP_SP_2020_23060_39184.jpg

LM Start	5.22	Rating **	A/W	Issue No.	69	
LM End	5.22	Issue Type +	Ma	Location *		
Category	Supplemental			GPS Latitude/Longitude		
				Start	End	
Item	DWR UCIP LMA Responsibility			37.675271 °	37.675271 °	
				-121.269281 °	-121.269281 °	
DWR ID	20686					
Comment Code						
Inspector Comment						
DS_ID:20686 FS_ID:23060 EP_NO: N/A Repair Type: No Action Needed Crossing Status: Found UCIP Comments: FIELD_STRUCT_DESC: 30-inch reinforced concrete drainage pipe through the levee, 10 feet below the crown. Concrete U-shaped headwall on the waterside (WS) end. Two corrugated metal cutoff walls. Flap gate on the WS end. [Additional Reference(s): DWR Levee Log, 2005. USACE San Joaquin O&M Manual 11, 1968, (HLM 5.12)]. FS Date: 9/5/2013

Cuts in pavement off LS toe good indicator of pipe location.

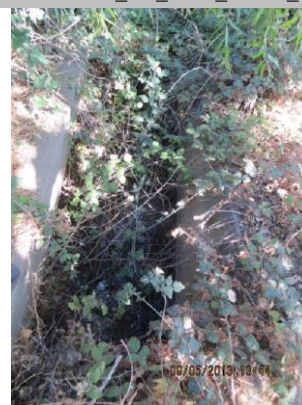
Photo 2 of 3 : UCIP_SP_2020_23060_39183.jpg

Concrete U-shaped headwall visible on WS toe.

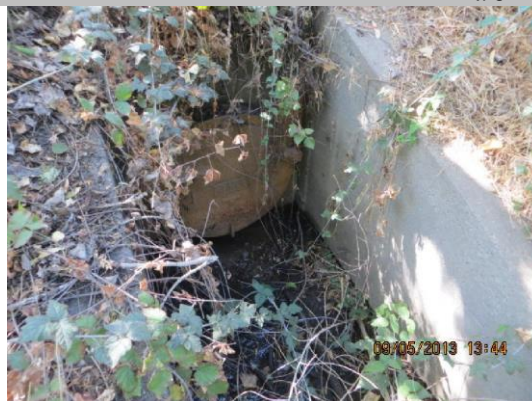
Photo 3 of 3 : UCIP_SP_2020_23060_39182.jpg

Concrete U-shaped headwall and flapgate visible on WS toe.

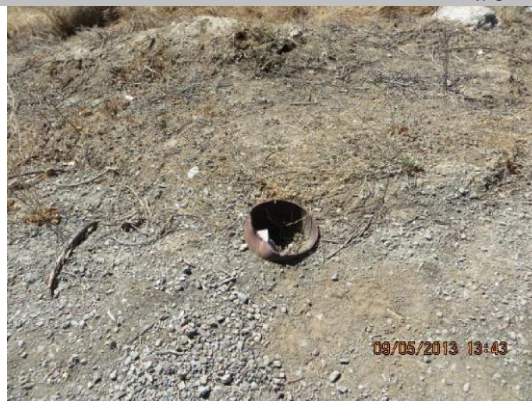
Photo 1 of 3 : UCIP_SP_2020_22290_38020.jpg

DS_ID:24058
 FS_ID:22290
 EP_NO: N/A
 Repair Type: Non-Urgent
 Crossing Status: Found
 UCIP Comments: No permit identified for this crossing.
 FIELD_STRUCT_DESC: 10-inch steel irrigation pipe through the levee, at an unknown depth. Siphon breaker in a 10-inch steel riser on the landside (LS) shoulder.
 FS Date: 9/10/2013

Siphon breaker in 10-inch steel riser on LS shoulder.

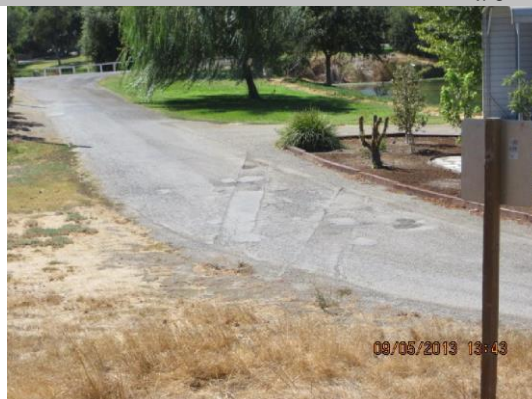
Photo 2 of 3 : UCIP_SP_2020_22290_38019.jpg

Cuts in pavement may indicate alignment of pipe at LS toe.

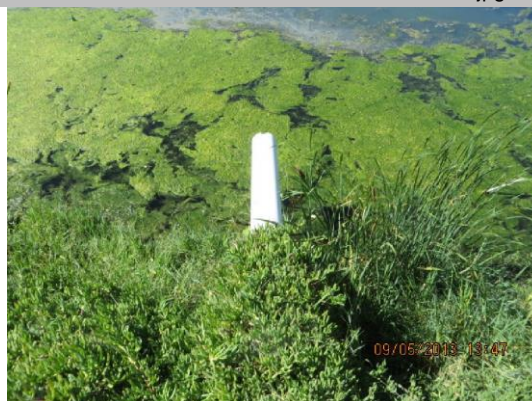
Photo 3 of 3 : UCIP_SP_2020_22290_38018.jpg

Pipe visible at pond outlet off LS toe.

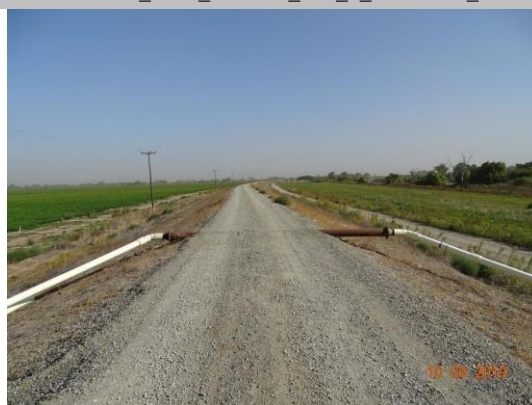
Photo 1 of 1 : SP_2020_RD2085_114_2_20200228_00001.jpg

View of pipe through levee. Fall 2019

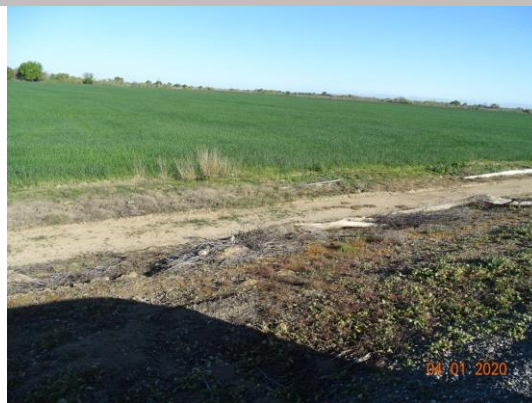
Photo 1 of 1 : SP_2020_RD2085_114_8_20200402_00002.jpg

View of prunings on landside slope. Spring 2020

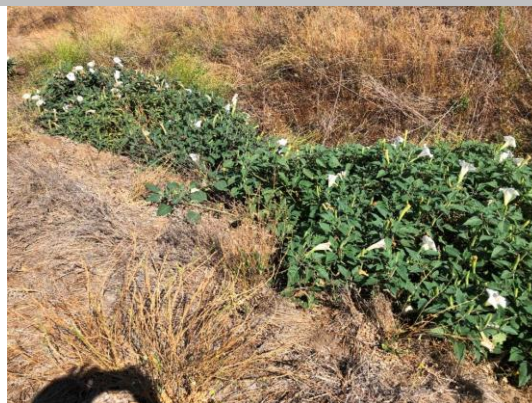
Photo 1 of 3 : SP_2020_RD2085_115_1_20200228_00001.jpg

Looking at the erosion site from levee top.

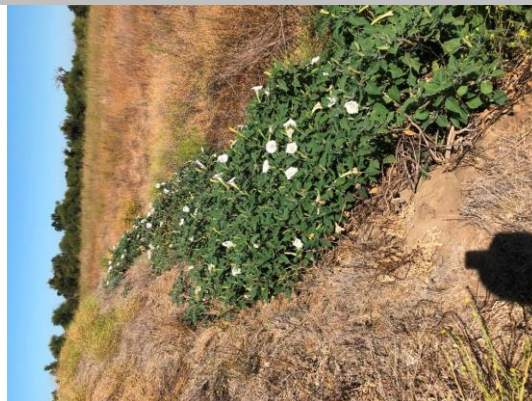
Photo 2 of 3 : SP_2020_RD2085_115_1_20200228_00002.jpg

Close view of the erosion.

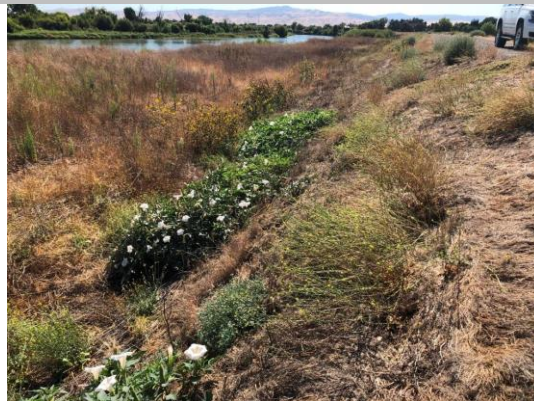
Photo 3 of 3 : SP_2020_RD2085_115_1_20200228_00003.jpg

Look upstream of the erosion.

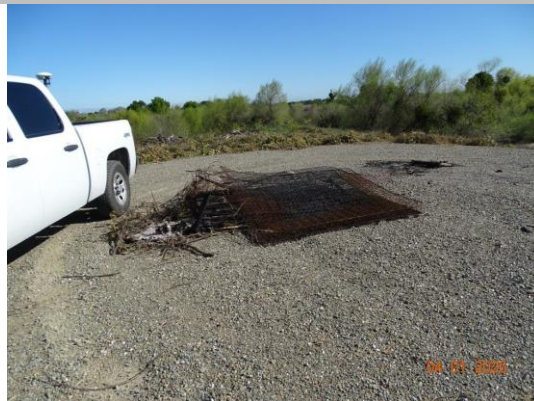
Photo 1 of 1 : SP_2020_RD2085_115_6_20200402_00006.jpg

View of debris on surface of crown road. Spring 2020
